BUREAU OF SHIPS GROUP
TECHNICAL INSPECTION REPORT

⑥ OPERATION CROSSROADS,
U.S.S. NEW YORK (BB34).

TEST BAKER

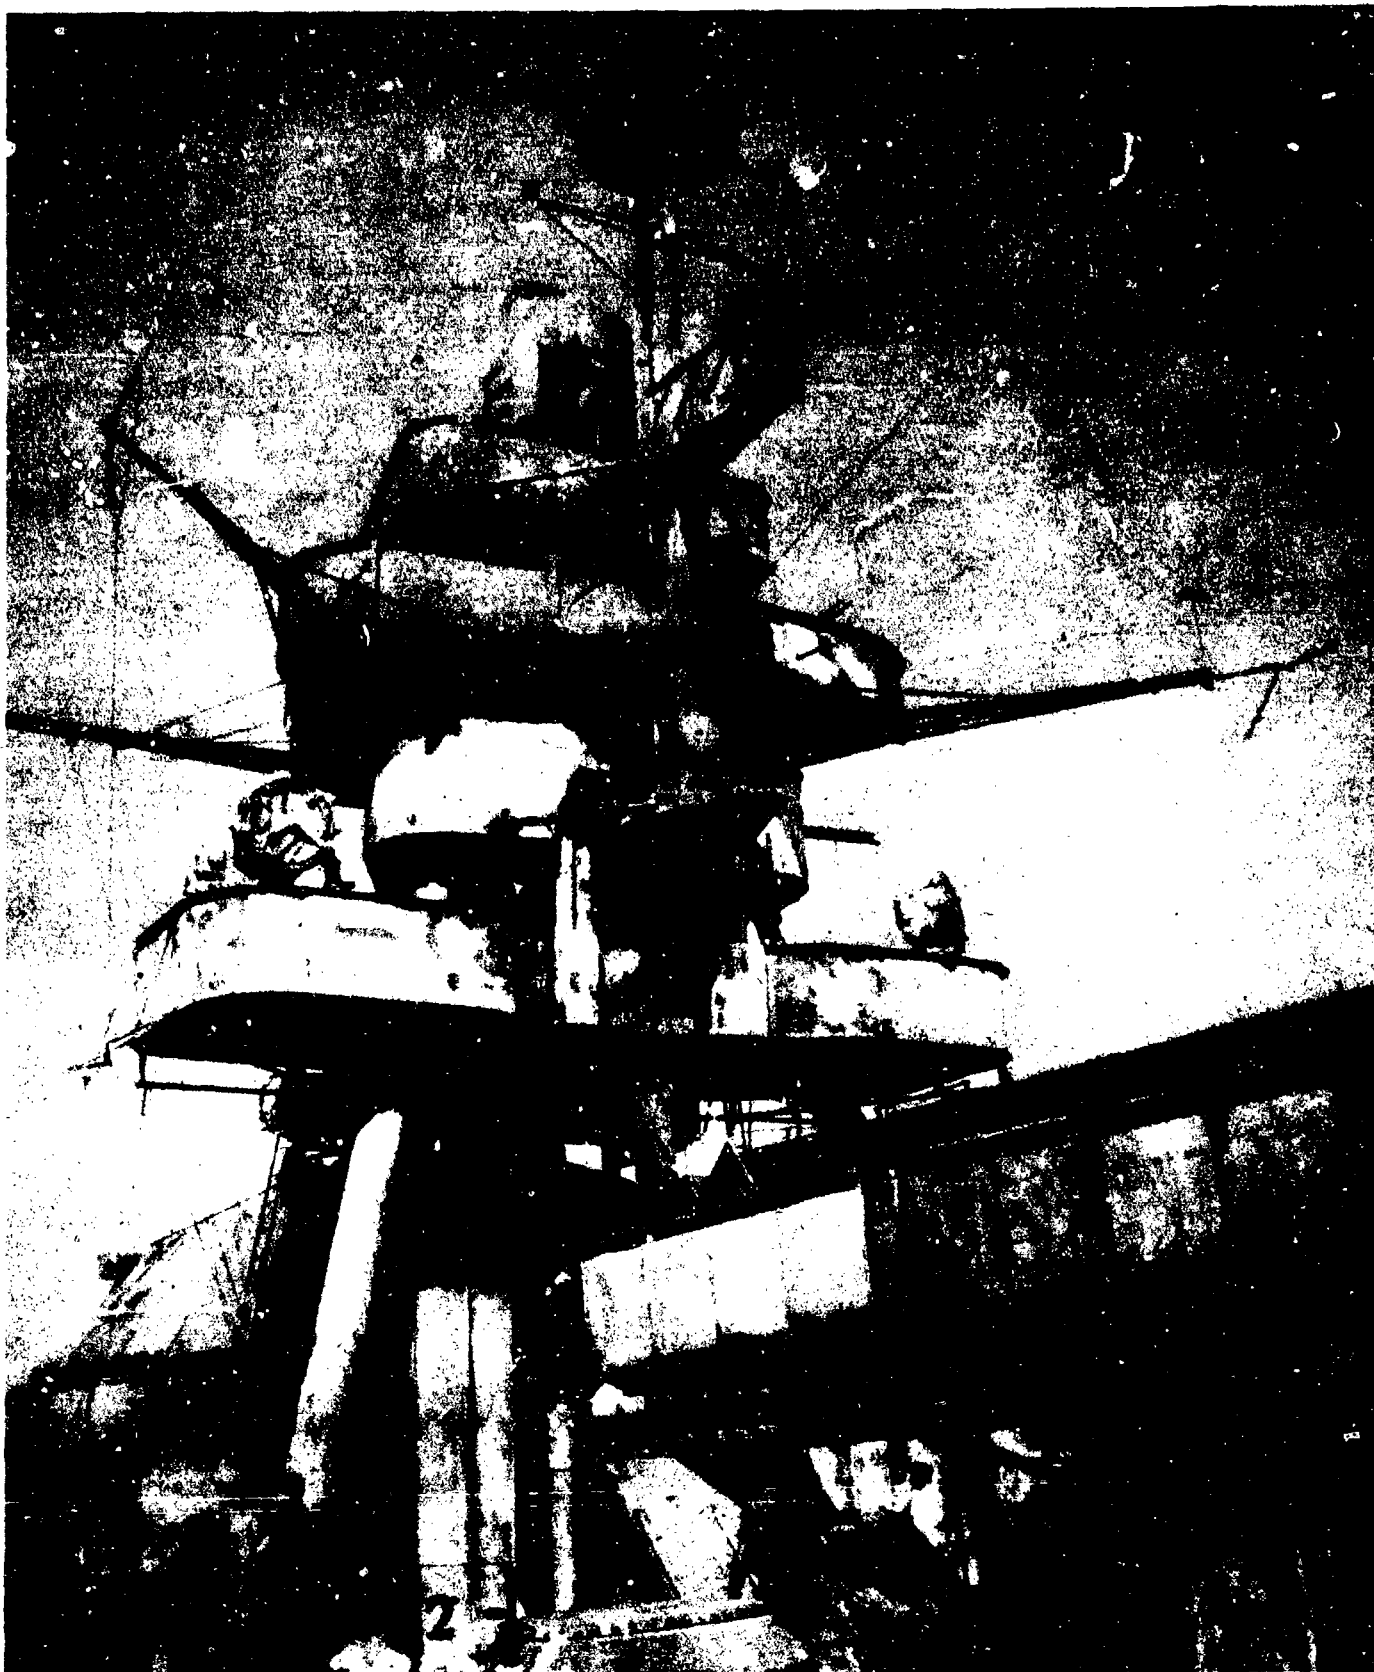
AB-CR-68-2952-6. Mainmast structure, looking aft and to port.

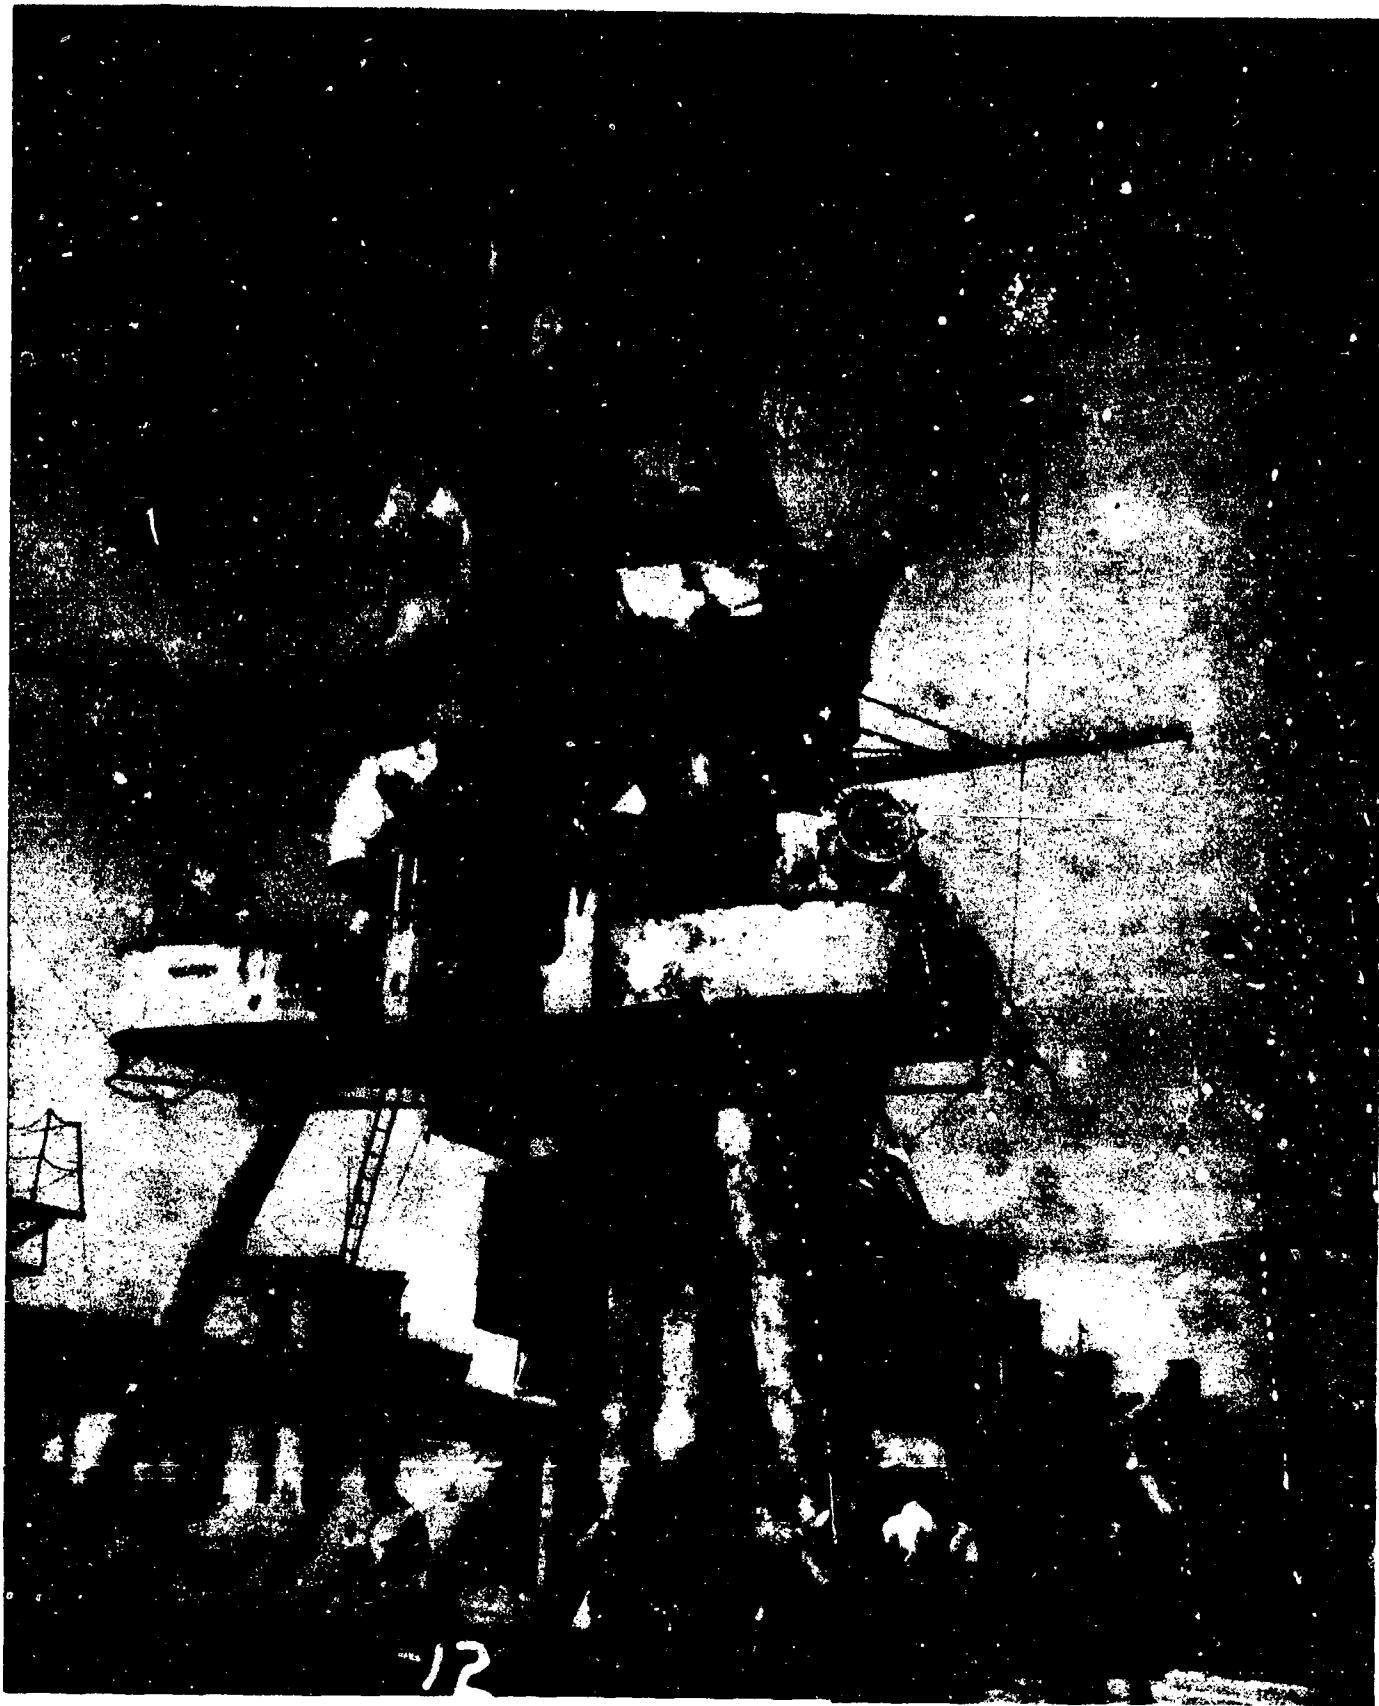
AB-CR-68-2952-12. Mainmast structure looking aft and to starboard.
